RESTORATION PLAN

May 2006

Conewago Creek

Dauphin, Lancaster and Lebanon Counties
Pennsylvania

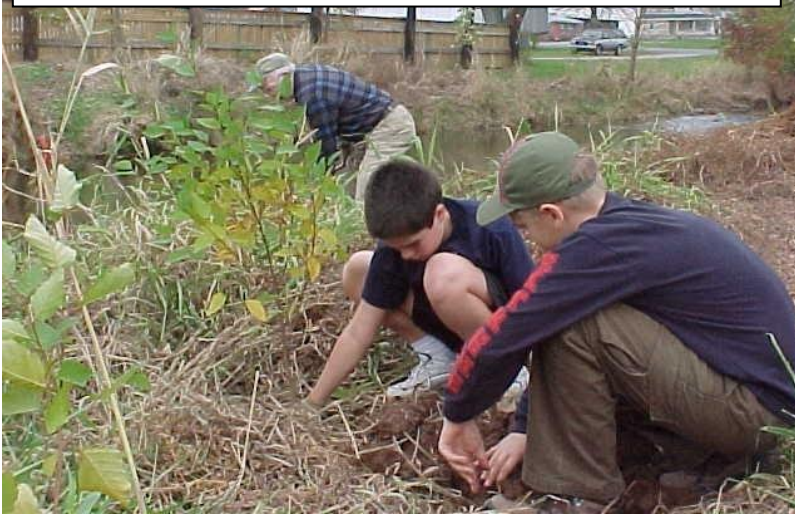
With help from a local scout troop, TCCCA volunteers plant a riparian buffer along the Conewago at a Hershey Trust farm in Mt. Joy Township, Lancaster County.

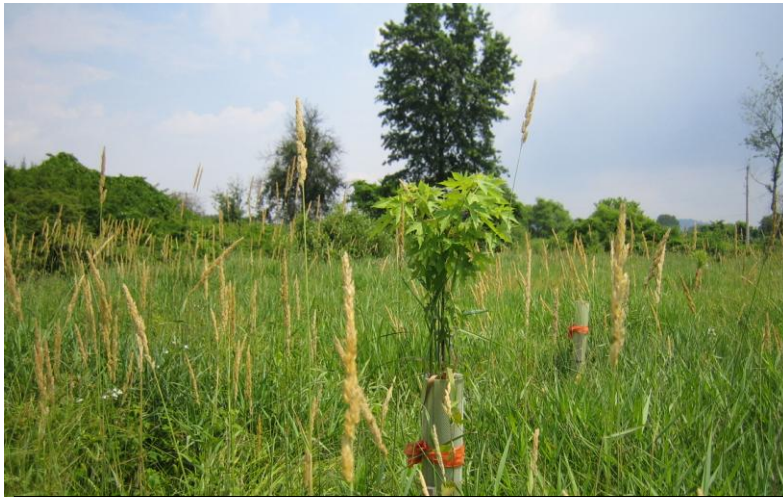
Stoffel farm riparian buffer project, South Londonderry Township, Lebanon County. Native grasses and young trees replace what was once a thicket of multi-flora rose.

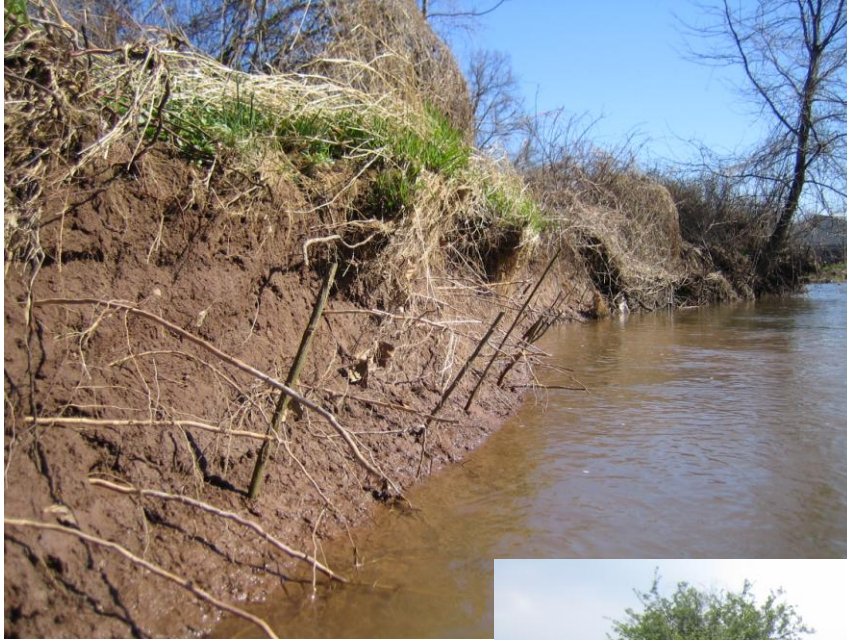
In order to stabilize eroded stream banks, TCCCA volunteers installed black willow live stakes at the Hess farm along the Little Conewago Creek. A year and a half after installation, many of the stakes have taken root and are helping to minimize bank erosion.

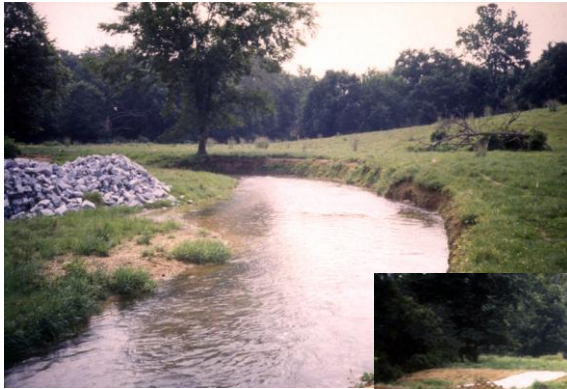
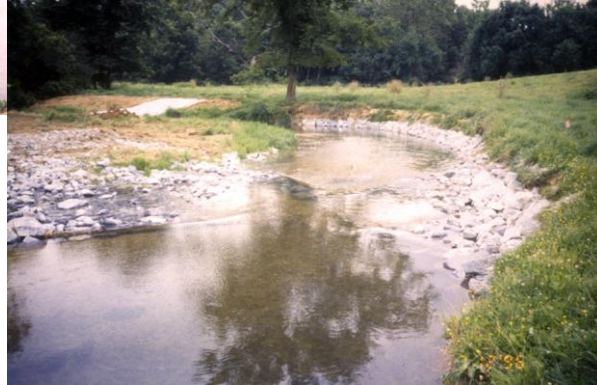
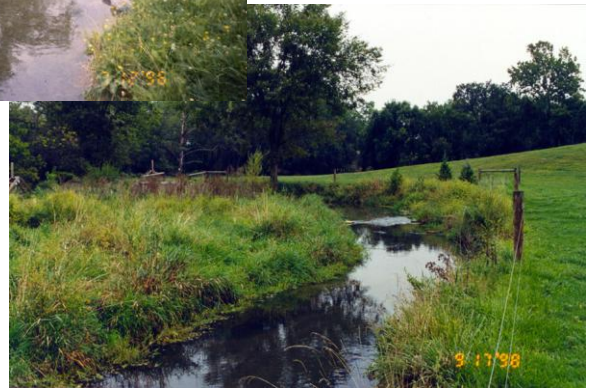
Stream bank stabilization projects such as this one involving stream bank fencing, riparian forest buffer plantings, the installation of two rock deflectors and rip-rapping combined with live stake plantings stopped the erosion in this cattle pasture without taking valued grazing acreage.

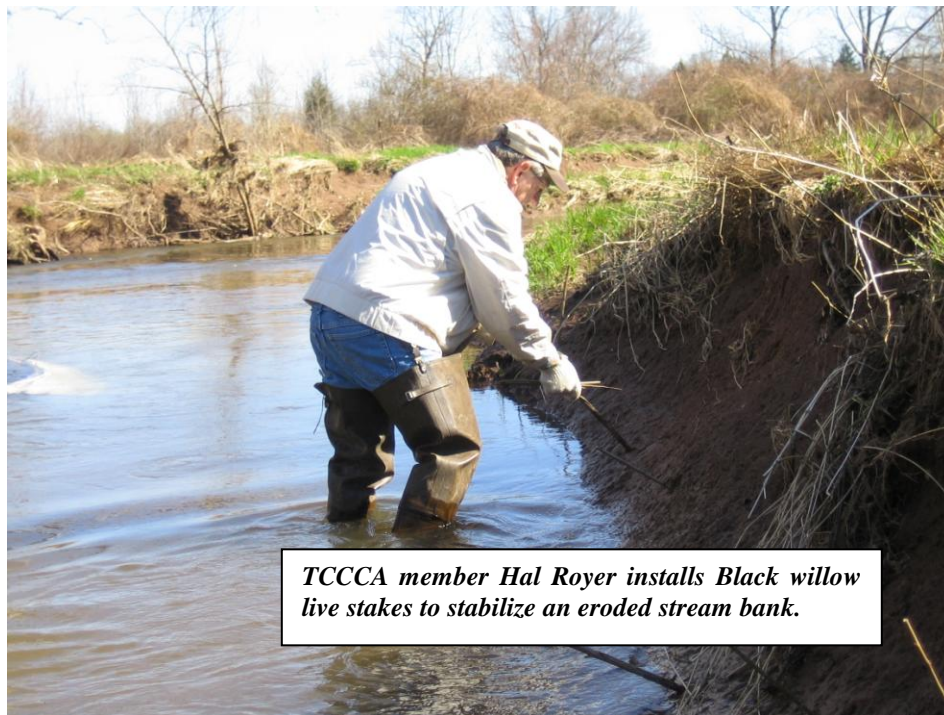
TCCCA member Hal Royer installs Black willow live stakes to stabilize an eroded stream bank.
